# ALERT

1. TITLE (Class, Function, Type, etc.) <b>Component Package, LCC-18, Ceramic Crack</b>		2. DOCUMENT NUMBER <b>FV5-A-07-01B</b>
		3. DATE (DD-MMM-YY) <b>01 August 2007</b>

## LCC-18 Ceramic Micro-crack Technical Review

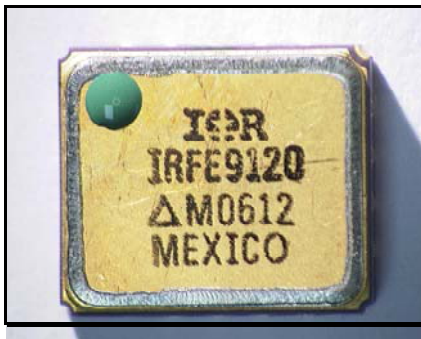
Picture showing Green Dot and location

5. Beginning 6/20/2007, material returned to IR for micro-crack verification will be marked to indicate acceptance. IR will add a Green Dot marking to those returned devices that have passed 100% inspection for sidewall micro-crack. LCC-18 product returned to the field with the Green Dot will provide positive identification of the inspection for micro-crack and acceptability thereof. Packages inspected that are found to exhibit a micro-crack will be segregated for scrap disposition. See picture below for Green Dot reference.
