1. TITLE (Class, Function, Type, etc.) <b>Component Package, LCC-18, Ceramic Crack</b>		2. DOCUMENT NUMBER <b>FV5-A-07-01B</b>
		3. DATE (DD-MMM-YY) <b>01 August 2007</b>

4. MANUFACTURER AND ADDRESS <b>International Rectifier Aerospace and Defense 204 Crawford Street Leominster, MA 01453</b>	5. PART NUMBER <b>See Document</b>	6. NATIONAL STOCK NUMBER <b>See Database</b>

## LCC-18 Ceramic Micro-crack Technical Review

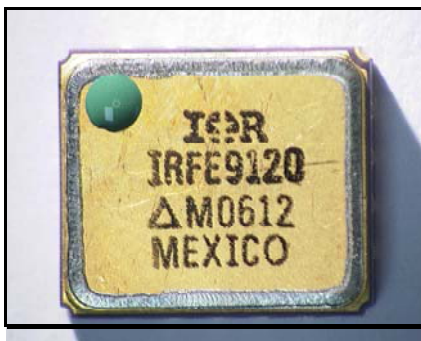
Picture showing Green Dot and location

5. Beginning 6/20/2007, material returned to IR for micro-crack verification will be marked to indicate acceptance. IR will add a Green Dot marking to those returned devices that have passed 100% inspection for sidewall micro-crack. LCC-18 product returned to the field with the Green Dot will provide positive identification of the inspection for micro-crack and acceptability thereof. Packages inspected that are found to exhibit a micro-crack will be segregated for scrap disposition. See picture below for Green Dot reference.

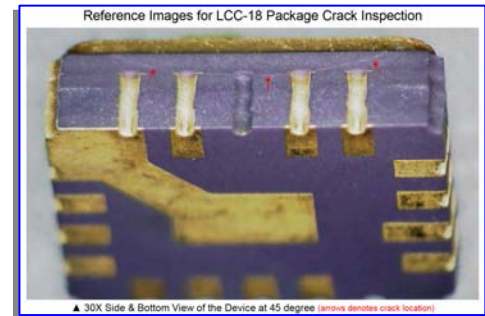
The following experiments were conducted to measure the performance of the LCC-18 parts that exhibit a micro-crack as reported in GIDEP FV5-A-07-01A. The data and results presented herein may be used to mitigate risk in certain field applications as it relates to hermetic seal performance and associated reliability following environmental stress conditioning. The device performance was verified by conducting fine and gross leak tests IAW MIL-STD-750 test methods and later validated by analyzing the internal gas content of the device by submitting to RGA (Residual Gas Analysis, MIL-STD-750, TM1018).

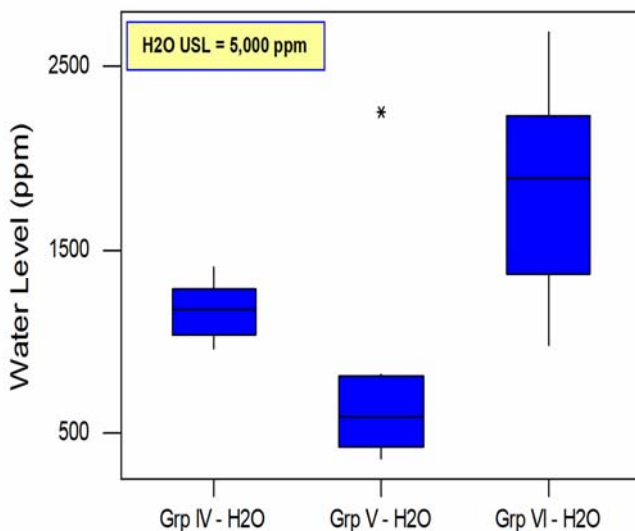
### WATER CONTENT (ppm)

Gas and moisture contents were obtained from each of the three groups. Parts were submitted and tested by an outside laboratory IAW MIL-STD-750, method 1018 (Pernicka Corp.). Note that the water moisture content limit (USL) is specified at 5,000 ppm and the upper limit for oxygen content is 2,000 ppm. All gases were found to read within nominal range. No indication of hermetic seal failure was detected as evidenced by gas level and content. Reference Boxplot exhibits below for key gas measure for each test group.
