GOVERNMENT - INDUSTRY DATA EXCHANGE PROGRAM		
PROBLEM ADVISORY		
1. TITLE (Class, Function, Type, etc.) Nickel Plated Kovar Lids		2. DOCUMENT NUMBER FV5-P-18-0001

3. DATE (DD-MMM-YY) 30-JAN-18
4. MANUFACTURER AND ADDRESS International Rectifier, HiRel Products 205 Crawford Street Leominster, MA 01453	5. PART NUMBER Various	6. NATIONAL STOCK NUMBER Not Applicable

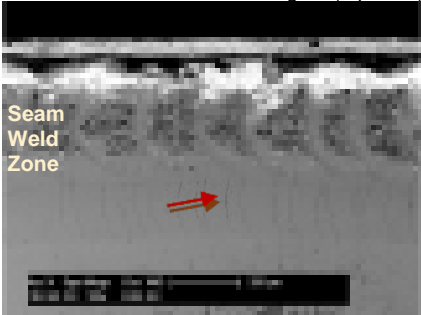
19. PROBLEM DESCRIPTION / DISCUSSION / EFFECT International Rectifier has identified that semiconductor devices that are seam welded with electroless nickel (NiP) plated Kovar lids can leak after exposure to MIL-STD-750, TM1041, salt atmosphere. This discovery was made irrespective of the fact that hermetic seal testing is not required following Salt Atmosphere for semiconductor devices (reference MIL-PRF-19500, Table E-VII, group C4). Failure analysis revealed hermetic seal leaks in the seam weld region. High magnification examination revealed the formation of micro cracks in the NiP plating at the seam weld that allowed salts to deposit and corrode through the underlying Kovar metal. Refer to image 1, 2 and 3 below for exhibit cracks in NiP.		
Image 1 Cracks in NiP at seam weld region (top view)	Image 2 Cross sectional view of seam weld region	Image 3 Top view of salt corrosion in Kovar

Scope: IR believes the problem is industry wide, where NiP plated Kovar lids are used in conjunction with seam welding. The nickel can crack in the heat affected zone of the seam weld, and expose base metal.

20. ACTION TAKEN/PLANNED In order to improve the robustness of IR semiconductor devices against corrosive environments or substances, an interlayer of electrolytic nickel will be added between the lid's Kovar base metal and external electroless nickel. Electroless nickel that contains 10 +/-2% phosphorus is brittle and can crack during the seam weld process. Electrolytic (Ni) nickel is more ductile than electroless (NiP) nickel and will act as a barrier to the Kovar base metal; hence making the product more robust. Implementation of the new Kovar lid plating is planned beginning March 2018.		
This Problem Advisory has been coordinated with DSCC-VQE and NASA prior to its release.		
Continued on page 2
