PRODUCT CHANGE NOTICE

1. TITLE Case Outline Lead Finish, Ceramic LCC style		2. DOCUMENT NUMBER FV5-C-12-006
		3. DATE August 27, 2012
4. MANUFACTURER AND ADDRESS International Rectifier 205 Crawford Street Leominster, MA 01453		5. MANUFACTURER PART NUMBER NA / LCC package types shown below

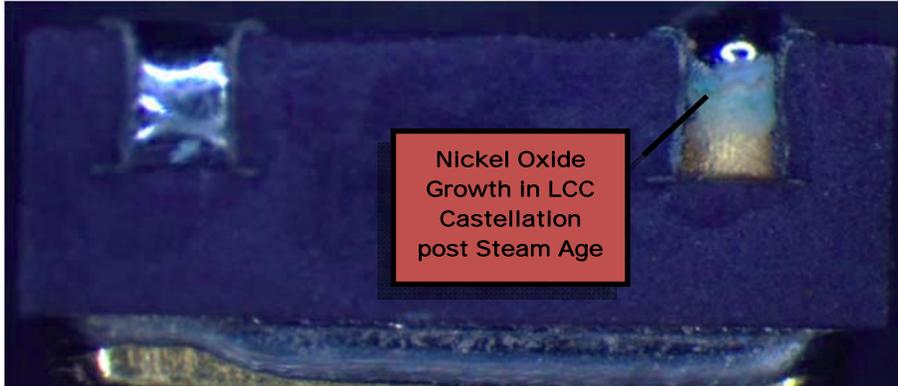
International Rectifier is experiencing solderability failures with their LCC-28, LCC-18, LCC-6, and LCC-4 style packages due to non-wetting in the lead castellation when tested in accordance with MIL-STD-750, TM2026 which invokes IPC/EIA J-STD-002, Category 3, Test B methods. The solder fails to wet at least two thirds of the way up the castellation, as required by J-STD-002. The failed leads often exhibit a visible nickel oxide (white or blue residue), which is usually concentrated in the castellation. (See figure 1 herein for exhibit). The nickel oxide is not removed by the RMA type flux specified in the solderability test method and inhibits wetting of the solder to the gold lead.

Figure 1 – Residue in Castellation, post steam age and solderability

The LCC leads have exposed Nickel and Tungsten (LCC package base metals) at the castellation edges, which is inherent with the package design due to singulation. Before any steam aging is performed, the LCC package castellation does solder and wet properly (even with no use of flux). However when performing solderability testing on the gold leads, the exposed base metals can oxidize during steam age and contaminate the castellation lead surface, leading to non-wetting of the gold surface.

While International Rectifier has not received any reports of solderability failure from the field, we are taking this improvement action of pre-tinning the parts before delivery to effectively prevent the growth of oxides in the field or during long term storage. The problem described herein is not new and not just specific to International Rectifier, but is common to the user community of the LCC package styles.
