PROBLEM ADVISORY

1. TITLE (Class, Function, Type, etc.) Hybrid Package Ceramic Seal Design		2. DOCUMENT NUMBER FV5-P-09-03
		3. DATE (DD-MMM-YY) 23 JULY 2009
4. MANUFACTURER AND ADDRESS International Rectifier, HiRel Business Unit 2270 Martin Ave. Santa Clara, CA 95050	5. PART NUMBER FSC 5962	6. NATIONAL STOCK NUMBER NOT AVAILABLE

19. PROBLEM DESCRIPTION / DISCUSSION / EFFECT (cont.)

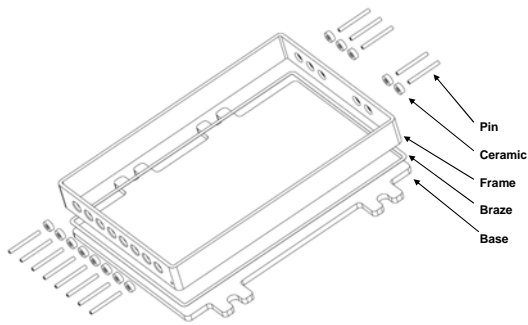
Figure 1 – Illustration of Hybrid Package Assembly Parts

Figure 2 – Photograph of Hybrid Package Ceramic Seal

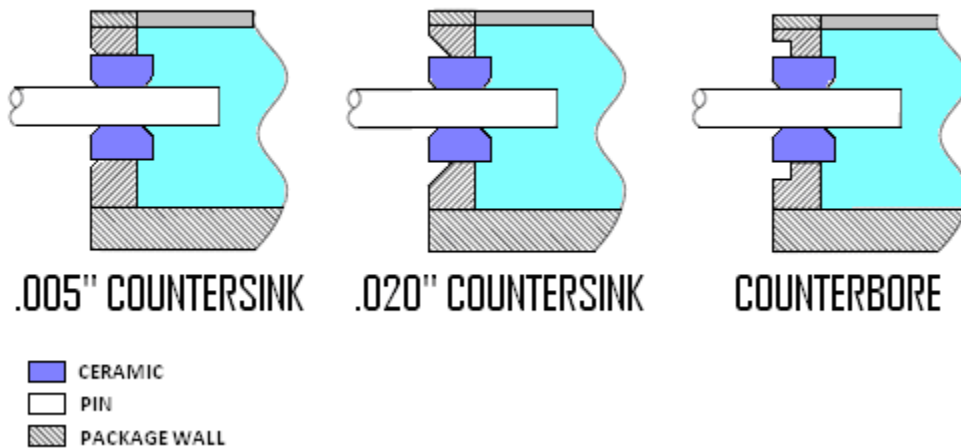
Figure 3 – Illustrations of different ceramic seal designs for 0.040 inch side walls. The 0.005 inch countersink in the side-wall is considered safe.

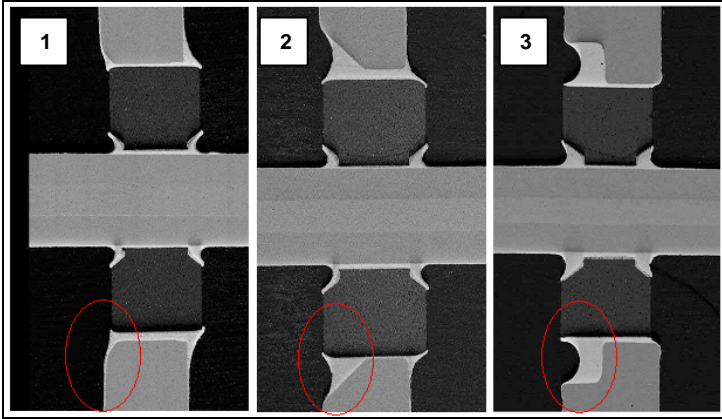
Figure 4 – Cross Sections (SEM Images) showing assembly details of different seal designs. Images 2 and 3 show the deep counter sink and counter bore designs that were shown to be problematic. The braze material fills the areas around the pin (inside the counter sink and counter bore), but the braze does not carry the same compression force as the frame material.

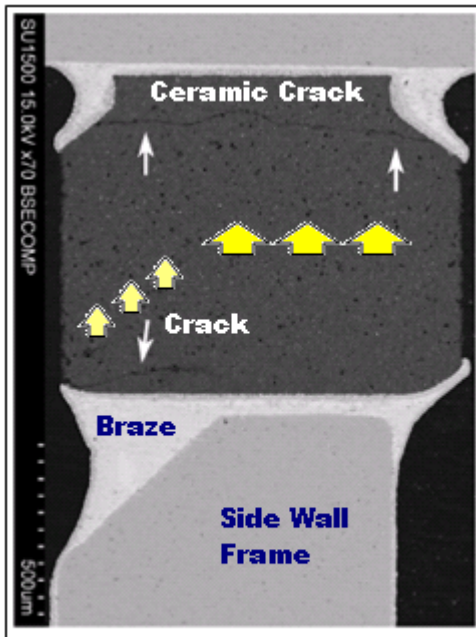
Mechanical analysis of the hybrid package seal revealed that the side-wall compression force was not uniformly applied across the ceramic feed through. This variation in the mechanical load between the pin and frame causes a tensile force on the ceramic, leading to cracks. During temperature excursions, the compression force differential is further aggravated by the material CTE properties. Through empirical studies with cross sections and package leak data, it was determined that the tensile force on the ceramic acted in proportion to the depth of the counter sink or counter bore feature in the package side-wall, which is used to control the amount of braze runoff. The deeper the counter sinks or counter bores in relations with the side-wall thickness, the greater the risk of leak failure (or ceramic cracks). See Appendix A – D herein for further details.

1. The deep counter sink does not allow sufficient compressive forces to be applied to the outer face of the ceramic.
2. The braze joint does not transfer enough compressive force from the frame to the ceramic.
3. This force imbalance creates a tensile force on the ceramic.
4. This condition can cause the ceramic to crack.

Figure 5 – Shows cross sectional image of ceramic seal with deep counter sink and ceramic cracks due to high tensile force.

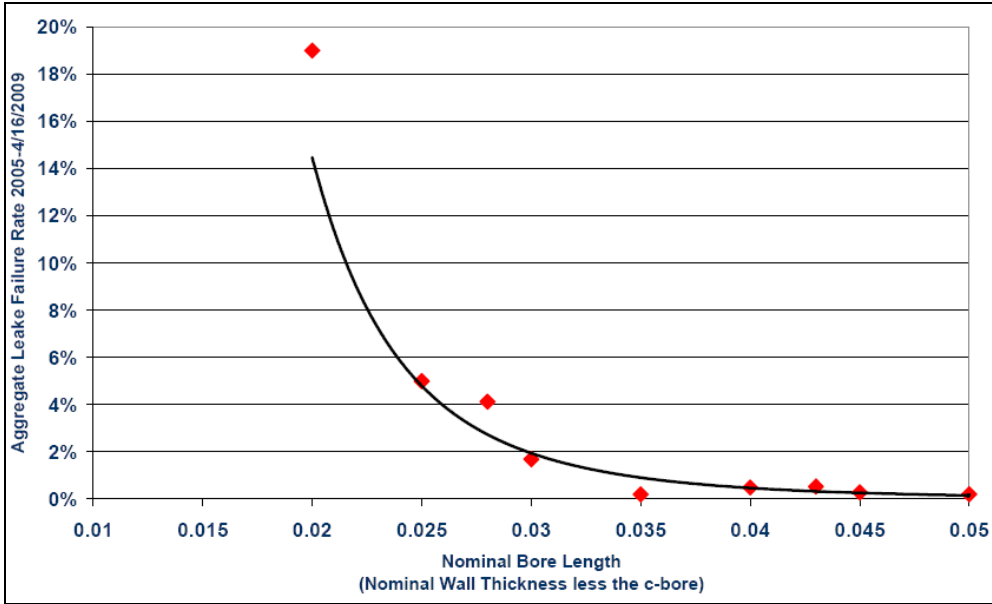
Figure 6 - Based on Package Manufacturing Yield Data: As the bore length of the frame increases, the hermetic failure rate decreases.
