PROBLEM ADVISORY

1. TITLE (Class, Function, Type, etc.) Capacitor, Chip, Ceramic		2. DOCUMENT NUMBER FV5-P-06-01A	
		3. DATE (DD-MMM-YY) 19 MAY 2006	
4. MANUFACTURER AND ADDRESS Novacap Inc. 25136 Anza Dr. Valencia, CA 91355	5. PART NUMBER See Document	6. NATIONAL STOCK NUMBER Not Available

FV5-P-06-01A (Amendment)

Tin Whisker Observations on Pure Tin-Plated Ceramic Chip Capacitors

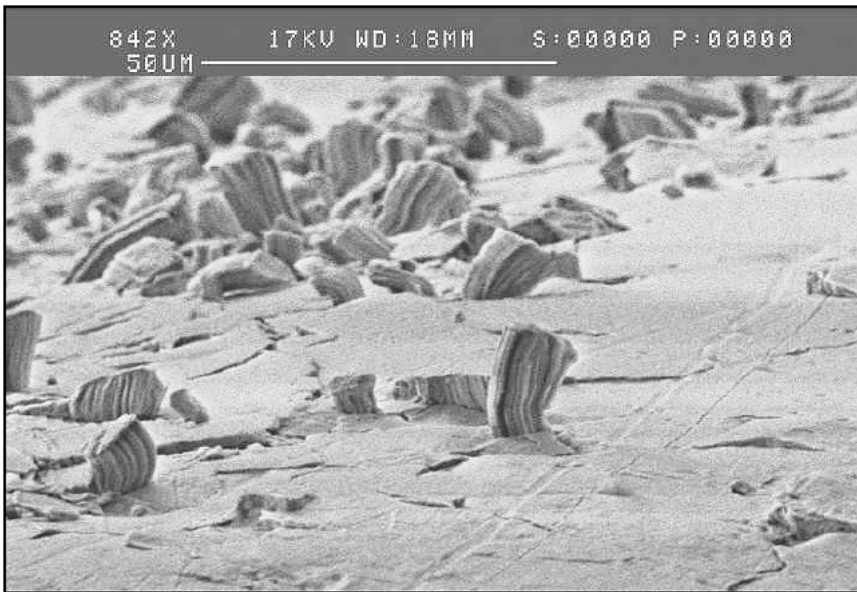
Capacitor samples were cross sectioned and construction was validated with a Nickel Barrier layer under the plated tin. The plated tin layer measured ~ 10um and the Ni barrier layer measured ~ 10um, which should act to limit the growth of whiskers. No tin whisker growth was observed on the capacitors in the hybrids as received (pre-conditioned to MIL-PRF-38534, Class H screen). Following submission to 100 Temperature Cycles (-65C to 150C), no distinct whisker growth was observed. Following a total of 200 Temperature Cycles (-65C to 150C), the presence of tin whiskers was observed on the capacitor terminations. Tin whiskers measured in the range of 15 to 20um in length. Reference photo 1 and 2 herein for exhibit.

Photo 1 – Growth of Tin Whisker following 200 Temperature Cycles

Based on results obtained from the experiments conducted, we can infer that tin whisker growth on the ceramic chip capacitor terminations appears to be limited to 15 - 20 microns in length. This inference is based on and represents a limited test scenario. As such, International Rectifier cautions against drawing conclusions concerning risk, reliability or performance impact based on the experiment results represented herein.

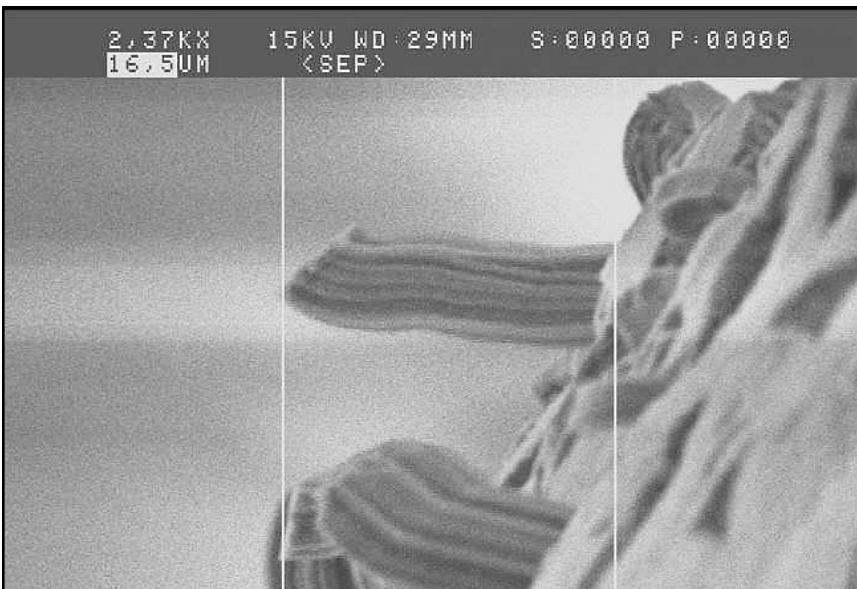
Photo 2 – Typical Tin Whisker ~ 16.5 micron in length (post 200TC)

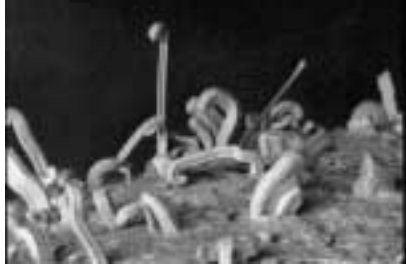
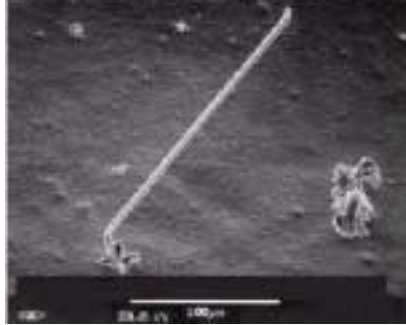
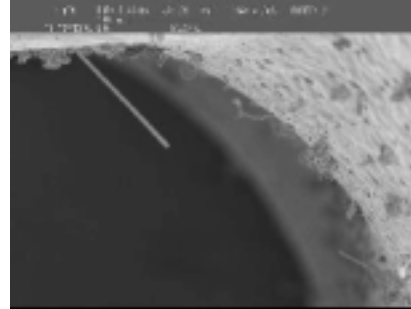
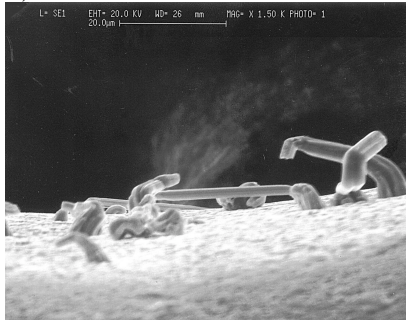
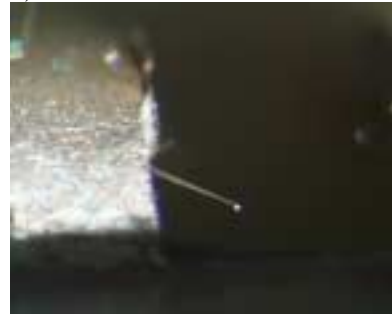
A) Ceramic Chip Capacitor Termination

C) Hybrid Microcircuit Lid

D) Terminal Lug

E) Test Points

F) DIP Microcircuit Lead

Figure 1: Examples of Electronic Components with Tin Whiskers (All are Pure Tin-Plated)

Figure 1 shows examples of tin whiskers on various types of pure tin-plated electronic components. As the name implies, tin whiskers are hair-like growths of near-perfect single-crystalline structures of tin that grow outward from some electroplated tin surfaces. Typical tin whiskers have diameters of only a few microns (μm) and have been reported to grow to lengths of several millimeters (mm), though lengths of less than 1-mm are typically reported^{1,6,7}. Their tiny dimensions make them extremely difficult to see unless proper illumination and/or high power inspection techniques are used such as scanning electron microscopy (SEM). In addition, troubleshooting of system problems may sometimes obscure whiskers as the root cause of failure if handling or probing is used which results in removal of the offending whisker.

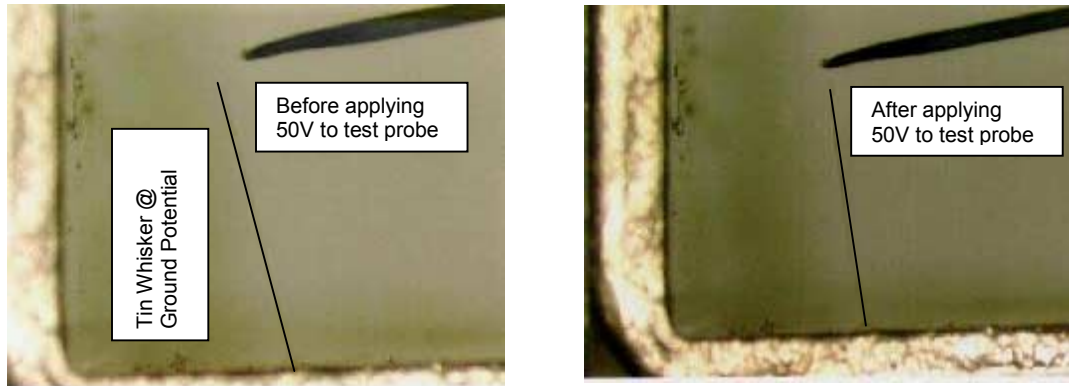
Figure 2. Tin Whisker "Bending" in Response to Electrostatic Attraction.

(Note: Photo has Been Enhanced to Aid in Observation of the Tin Whisker which is Difficult to See in this Optical Photograph)

In previous work performed at the NASA Goddard Space Flight Center (GSFC), it has been demonstrated that tin whiskers (especially the longer, filament types) will bend in response to forces of electrostatic attraction (see Figure 2)¹³. Therefore, a tin whisker growing from a surface at one electrical potential will be attracted towards an adjacent conductor with a different potential. This behavior is highlighted to show that the probability of a tin whisker shorting event is greater than a "random" occurrence dependent solely on the whisker's direction of growth.

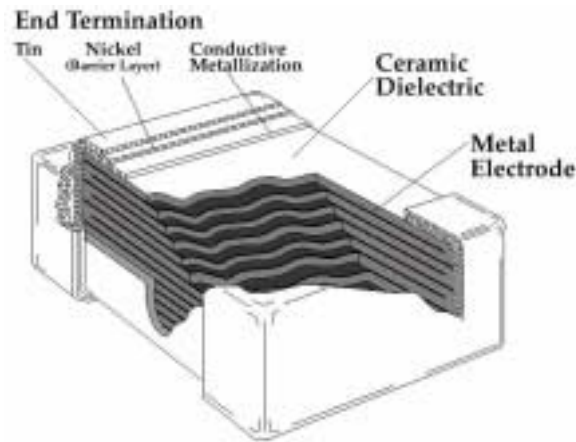
Figure 3. Typical Cutaway View of a Tin-Plated Multilayer Ceramic Chip Capacitor (Kemet Electronics Corp Data Sheet)

The capacitor element consists of layers of a ceramic-based dielectric material (e.g., barium titanate) with metal electrodes (e.g., palladium-silver [Pd-Ag]) interleaved. The ceramic-electrode structure is sintered at high temperature to form a homogenous block. Conductive terminations are applied to the ends of this ceramic block to provide electrical contact points for this surface mountable device. The end termination structure typically consists of three distinct layers as follows:

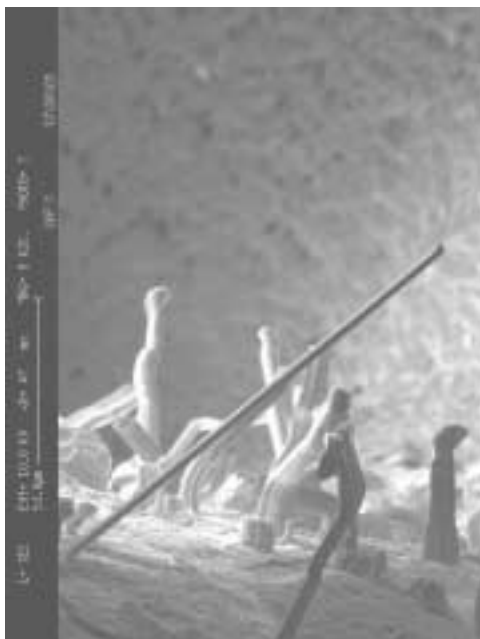
Figure 4. Pure Tin-Plated MLCC from Manufacturer "A" with Tin Whiskers (Max. Whisker Length ~100-μm in this Image)

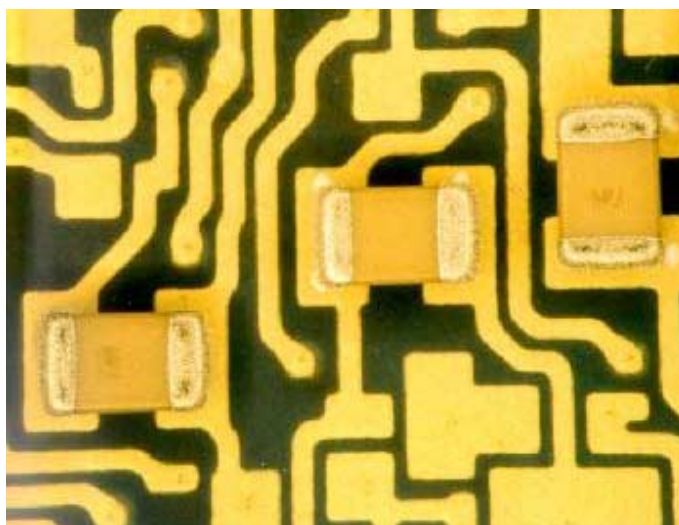
sealed hybrid microcircuit. The OEM's mounting process employs a widely used silver-loaded conductive epoxy to accomplish the bond between the substrate pads and the MLCC terminations (Figure 5). Once assembled, the hybrids are hermetically sealed in a Nitrogen atmosphere. These assembly practices are commonly used in the manufacture of complex hybrid modules. However, the use of pure tin MLCCs with conductive epoxy is not a recommended practice due to potential mechanical and electrical integrity concerns when bonding epoxies to tin or tin-lead.

Figure 5: Optical View of Hybrid Package Substrate with Epoxy Mounted Pure Tin-Plated MLCCs (MLCC dimensions 2.03 mm x 1.27 mm)

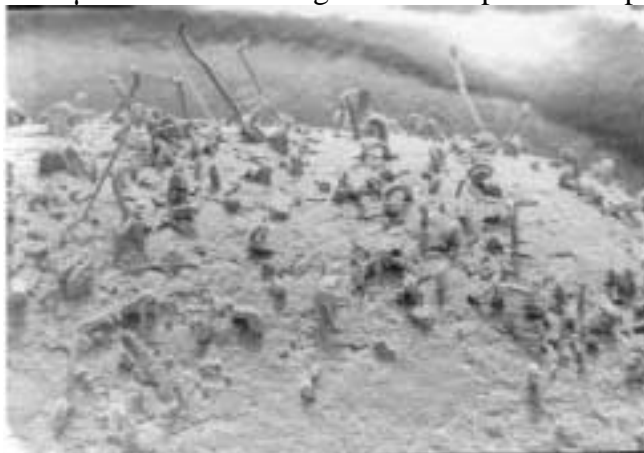
The OEM reported that the representative hybrid had been subjected to 200+ thermal cycles of test Condition 1. As received by GSFC, the hybrid package had already been delidded by the OEM for optical inspection only (i.e., the MLCCs were still epoxied to the substrate). Upon receipt of the hybrid, GSFC parts analysts performed SEM inspection. Figure 6 shows the profuse density of growths (as high as 800 per mm²) and maximum whisker lengths on the order of 100- μ m thus confirming the OEM's previous reports.

Figure 6: NASA GSFC SEM Inspection of Pure Tin-Plated MLCC from Manufacturer "A" with Tin Whiskers

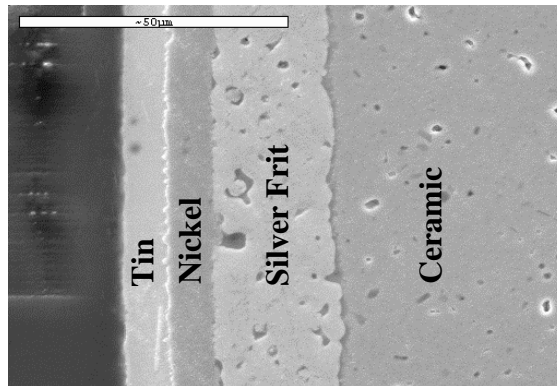
Figure 8: Cross-Section of MLCC Indicating the Thickness and Composition of the Various Layers

The bulk ceramic dielectric was observed to be of a commonly used barium titanate formulation.

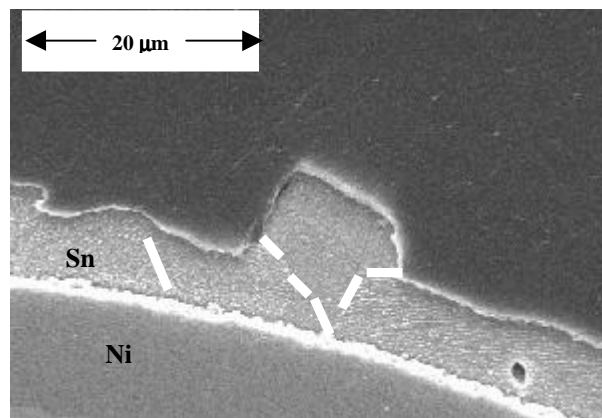
The cross-sectioned MLCC was next chemically etched to highlight the grain structure of the tin electroplate. Though difficult to see in Figure 9, this analysis showed that the tin grains were polygonal structures ranging from 5 to 15- μm in size.

Figure 9. Tin Etch of Cross Section of MLCC Termination Structure with Grain Boundaries Highlighted

The results of the cross section analysis show that the attributes of this MLCC are essentially identical to those of the MLCCs reported to be whisker-free after 18 years in the earlier studies.

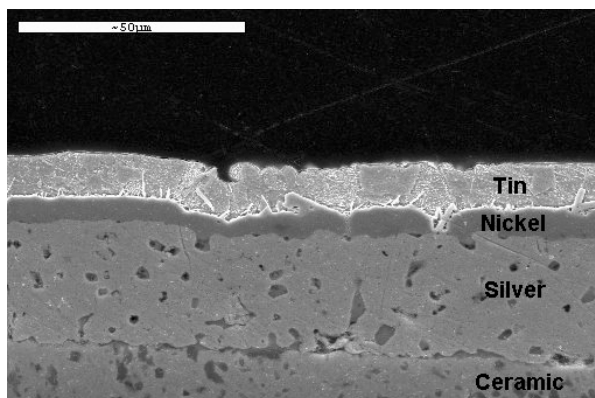
In a study to assess the risk of tin whisker formation, The Aerospace Corporation obtained pure tin-plated MLCCs from two different manufacturers ("B" and "C"). The MLCCs from Manufacturer "B" are typical commercial grade capacitors whose cross section is shown in Figure 10. Note that this lot of MLCCs contains a nickel barrier layer ~ 6- μm thick with a pure tin final finish ~10- μm thick

Figure 10. Cross-Section of Pure Tin-Plated MLCC from Manufacturer "B"
("Typical" MLCC Construction with Nickel Barrier Layer)

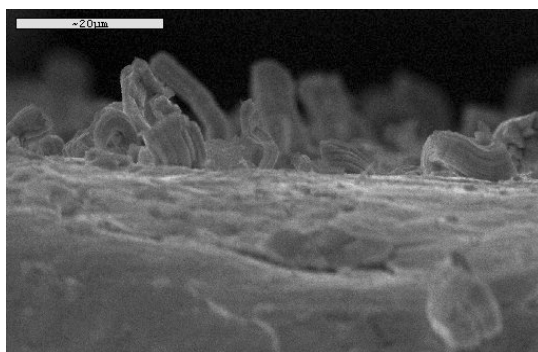
All of the capacitors were then subjected to the same environmental test described by Condition #1 of Example #1 (thermal cycle). Capacitors from Manufacturer "B" were examined after 500+ cycles and densely populated regions of tin whiskers up to ~25- μm in length were observed (Figure 11) even for those parts exposed to simulated reflow. The MLCCs from Manufacturer "C" were examined after 100 cycles and also showed evidence of whiskers ~25 to 30- μm long (Figure 12).

Figure 11. Tin Whiskers on Pure Tin-Plated MLCCs from Manufacturer "B" After Thermal Cycle

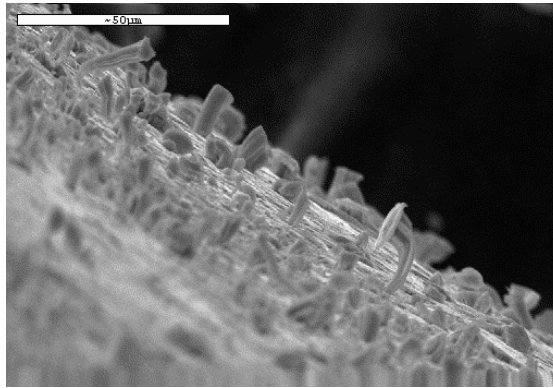
Figure 12. Tin Whiskers on Pure Tin-Plated MLCCs from Manufacturer "C" After Thermal Cycle

The results of these experiments confirmed most of the observations from Example #1. However, the maximum length of the whiskers found in Example #1 were from 3 to 10 times longer than those observed in Example #2. It will be interesting to see if the whiskers from Example #2 continue to grow under ambient storage as reported in Example #1.
